# Case Studies in Engineering Failure Analysis

# Failure analysis of a diesel generator connecting rod

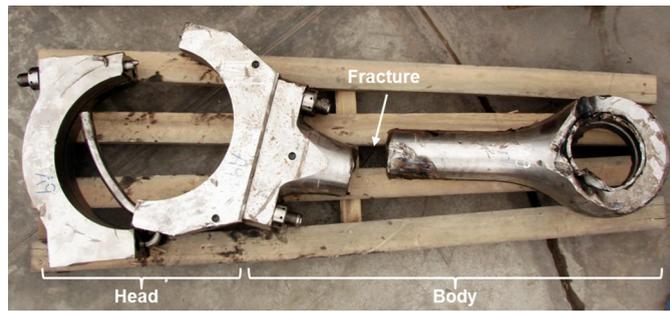
This paper presents the results of a failure analysis investigation conducted in a connecting rod from a diesel engine (18 V, four-stroke) used in the generation of electrical energy. The continuous output of the engine was 10.5 MW, at 600 rpm; before the failure of the con-rod it accumulated 35836 service hours, working with a load factor of 80%. The connecting rod (total length: 1463 mm, weight: 134 kg) had a drilled channel along its body, through which pressured lubrication oil was transported to the piston pin. Fig. 1 shows the failed con-rod, which fractured in the body section, close to the head.

Fig. 1. Failed connecting rod.

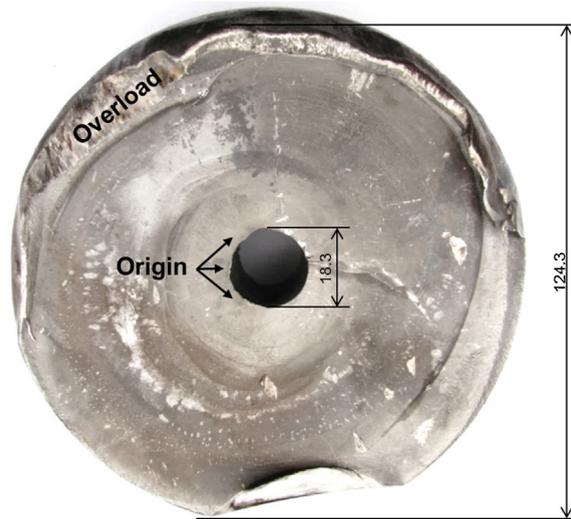
Fig. 3. Fracture surface of the connecting rod.

Fig. 3 shows the fracture surface of the connecting rod. The con-rod fractured in the body through a section perpendicular to its axis, close to the head. Previous investigations reveal that connecting rods are prone to fail in this area, since the highest deformation and level of stresses, according to finite element simulations, occur in this location [15,16]. A fatigue pattern with beach marks was observed; fatigue cracking initiates in multiple sites at the lubrication channel, as seen in Fig. 3(a), and propagates to the external part of the con-rod. Fatigued area covers more than 75% of the connecting rod section, suggesting low magnitude nominal stresses; the rest of the fracture pattern exhibits an overload pattern, as shown also in Fig. 3.

Although a fatigue fracture is typical in cases of failure of connecting rods, the observed pattern (i.e. from the center to the exterior), is not common. Therefore, the analysis at the fracture zone was focused on the origin of the fracture (i.e. the lubrication channel).

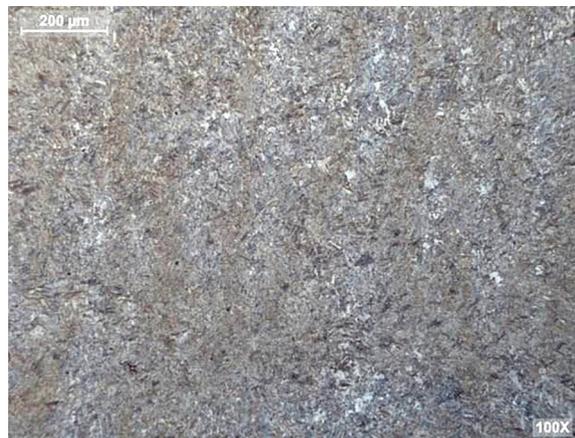
Table 3 shows the results of the hardness test. The obtained average hardness value was 276 VH. The metallographic analysis of the con-rod material revealed a tempered martensite microstructure, as observed in Fig. 4. The values of the properties and the microstructure are consistent with those reported for an AISI/SAE 4140 steel in the quenched and tempered state [17], and are appropriate for an application as a connecting rod.

Fig. 4. Microstructure of the connecting rod material.

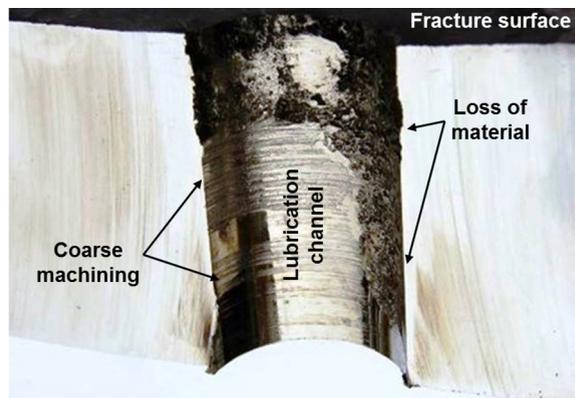
Fig. 5 shows an image of the longitudinal cut through the lubrication channel at the fracture zone. Very coarse machining marks as well as an area that exhibit loss of material were identified in the channel. Magnetic particle examination revealed

Fig. 5. View of the lubrication channel at the fracture zone.

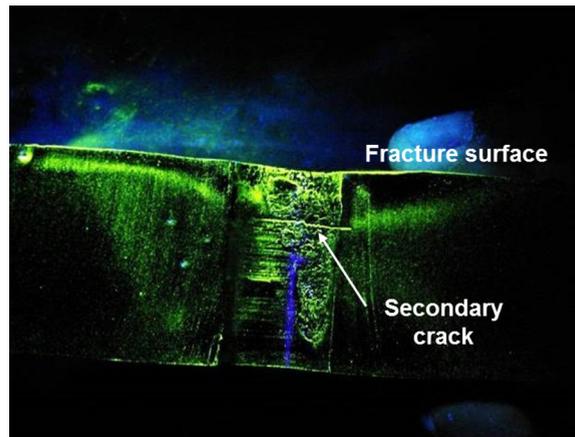
Fig. 6. Secondary crack revealed by magnetic particle inspection.

the presence of secondary cracks parallel to the fracture surface, as observed in Fig. 6. It is clear that cracks propagate from the lubrication channel to the exterior surface of the connecting rod, as indicated for one secondary crack (white arrow) in the figure.

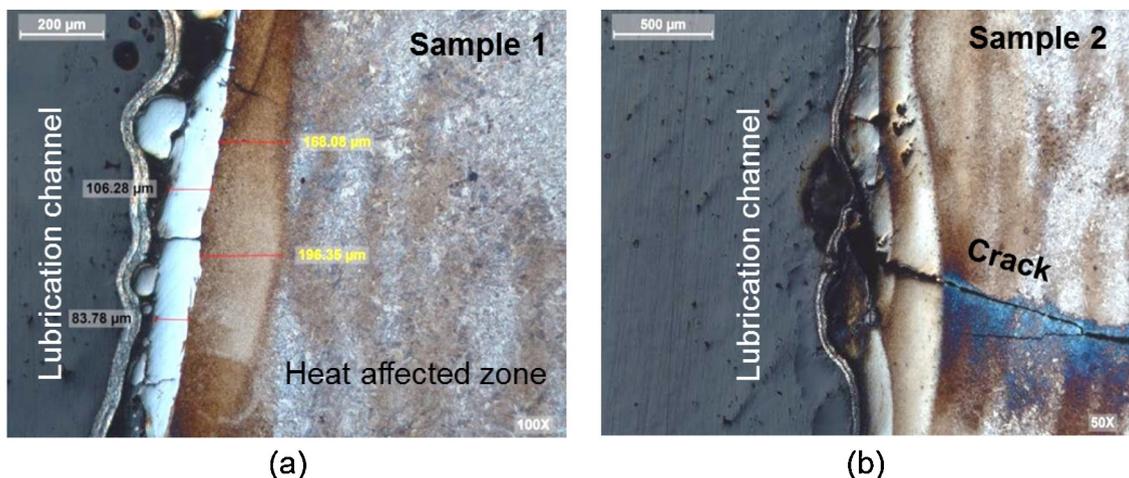
Metallographic samples examination (samples 1 and 2) revealed the presence of a white layer (as observed in the micrographs) in the surface of the lubrication channel, where cracks nucleate, as observed in Fig. 7(a). Cracks propagate toward the exterior of the con-rod, as seen in Fig. 7(b). The white layer exhibits a wide-ranging thickness, Fig. 7(a) shows two thickness measurements: 106.28 and 83.78  $\mu\text{m}$ . In addition, a heat affected zone with a varied size was identified; Fig. 7(a) also shows two measurements: 196.35 and 168.08  $\mu\text{m}$ .

Fig. 7. Micrographs of the microstructure at the lubrication channel, sample 1 (a) and sample 2 (b).

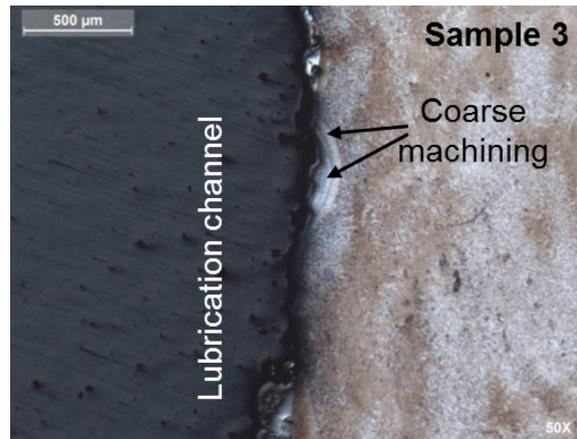
An analysis of sample 3, away from the fracture zone, do not show evidence of the white layer or the heat affected zone. However, a coarse machining finishing of the channel is observed in these areas, as shown in Fig. 8.

Fig. 8. Micrograph of the microstructure at the lubrication channel in sample 3.

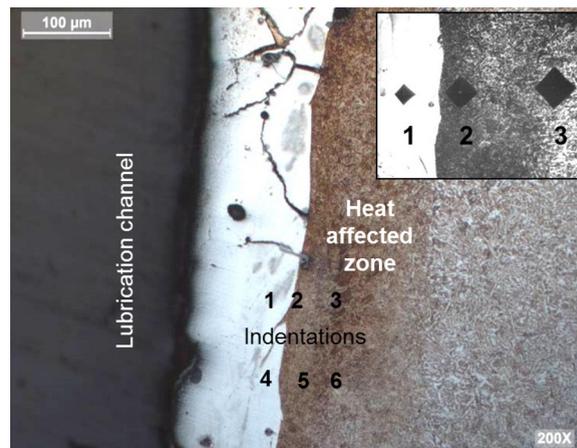
Fig. 9 presents the hardness test indentations (1–6) of the lubrication channel sample at the fracture zone, the inset shows a close up view of the indentations 1–3. Table 4 presents the results of the test. The white layer exhibits an extremely high hardness value, of approximately 1000 HV (indentations 1 and 4), which is not possible to attain with an AISI/SAE 4140 steel. Therefore, it is evident that the white layer is composed of a material that has been embedded in the steel matrix. The presence of a heat affected zone (indentations 2 and 5), with a hardness value of up to 408 HV, indicates that the process to embed this material in the steel involved high temperatures.

Fig. 9. Hardness test indentations (1–6) in the fracture zone.

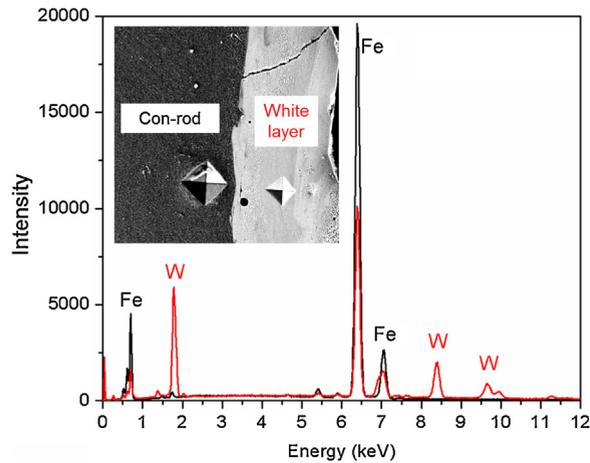
The microanalysis revealed the composition of the white layer. As observed in Fig. 10, which shows the superimposing of two energy dispersive spectra (i.e. the white layer (red line) and the rod material (black line)), the white layer contains a high amount of tungsten (W). This is confirmed with a line scan test, performed from the internal part of the rod to the white

The presence of tungsten and the evidence of exposure to temperatures high enough to promote its embedding in the steel substrate and the formation of a heat affected zone, are compatible with the process of electrical discharge machining (EDM). In EDM an electrically conductive material is machined by producing a controlled and localized electric spark between an electrode and a workpiece [18]. Temperatures involved in this process could reach values up to 12,000 °C and tungsten based materials are used as electrodes. Therefore, it could be presumed that EDM was used to machine the lubrication channel and that the embedding of W and the formation of the corresponding heat affected zone were produced as a result of its deficient application.

Fig. 10. Energy dispersive spectroscopy spectra for white layer and rod material. (For interpretation of the references to color in this figure citation, the reader is referred to the web version of this article.)

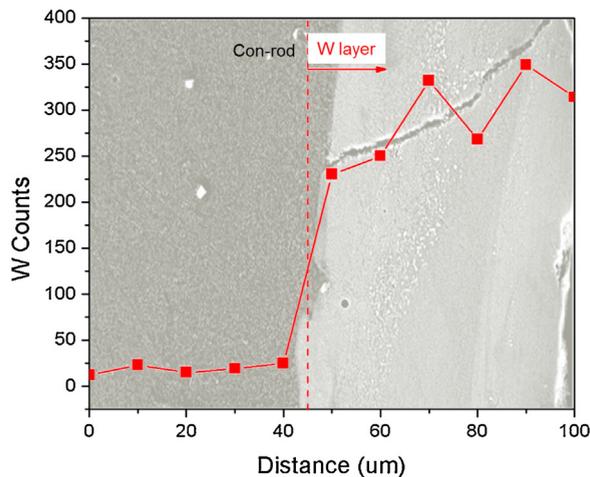
layer; as observed in Fig. 11 the content of W increases dramatically right at the interface between the heat affected zone and the white layer.

Fig. 11. W content variation from con-rod material to W layer.
