# Case Studies in Engineering Failure Analysis

# Failure analysis of a diesel generator connecting rod

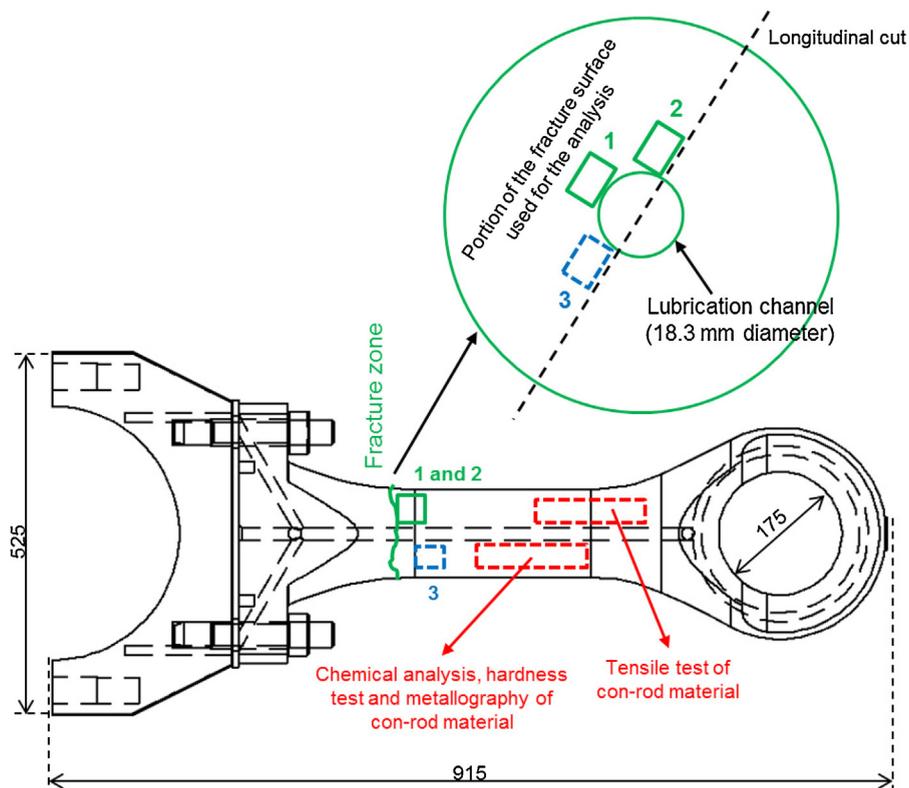
Then, a comprehensive characterization of the con-rod material was conducted; samples were removed from a zone away from the fracture zone (Fig. 2 shows the location of samples for the tests, as well as the dimensions of the con-rod) in order to carry out the following tests: chemical analysis, hardness test, metallographic analysis, and tensile test. Chemical analysis was conducted with a Bruker Magellan Q8 atomic emission spectrometer, according to ASTM E415-14 [10]. Tensile tests were conducted in longitudinal samples (2) located at the mid radio of the body of the con-rod, tests were conducted according to ASTM A370-15 standard [11] using a Zwick Roell Z250 tensile test machine. Hardness testing was conducted according to ASTM E384-11e1 standard [9] employing a Zwick Roell ZHV30 hardness tester (9 indentations). Samples for metallographic analysis were prepared according to ASTM E3-11 [12] and ASTM E407-07(2015)e1 [13] standards, they were mounted in epoxy resin and subjected to a grinding and polishing processes with sand paper and diamond paste, respectively. Samples microstructure was revealed after chemical etching with a 2% Nital solution; the analysis was carried out with a Leica M2 optical microscope, equipped with a digital camera.

Fig. 2. Location of samples for the analysis of the con-rod material and the fracture zone.
